“Full” Reserve Study

Parc on Summit Seattle, WA

Report #: 17969-0
For Period Beginning: December 1, 2012
Expires: June 30, 2013

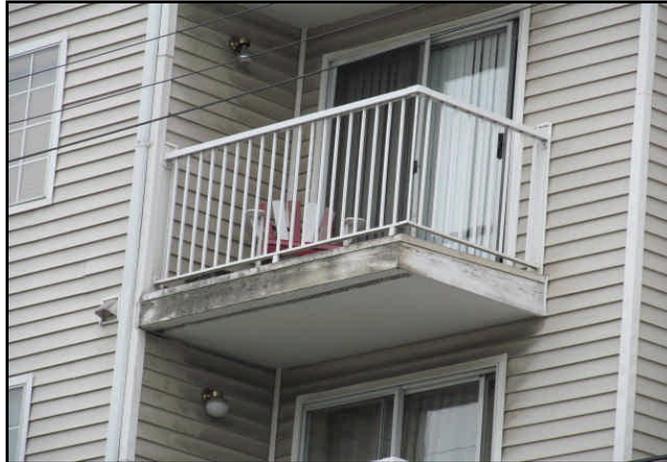
Location: Elevated balconies, decks adjacent to individual units

Evaluation: Replacements along with deck repairs and resurfacing are likely. Installation of fascia mounted design to reduce deck surface penetrations are often selected when major deck renovations occur. We recommend regular professional inspections to ensure safety and stability with prompt repair as needed from operating budget. Pay particular attention to attachment points to also maintain waterproofing. No anticipation of needs for refinishing aluminum rail; but clean and seal along with other exterior building components.

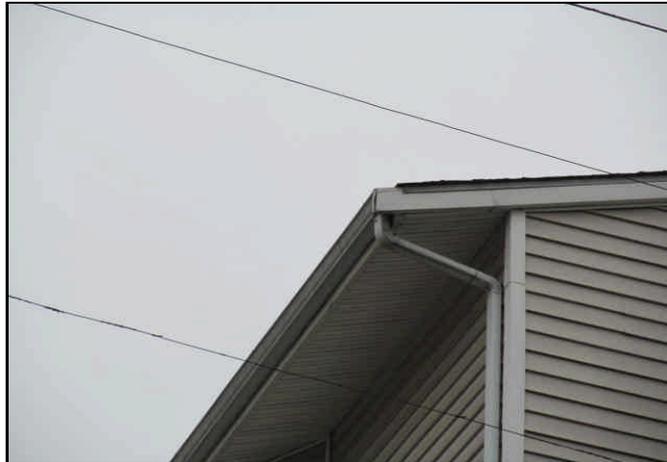
Location: Perimeter of buildings

Evaluation: Majority appears older. Replacement at the same intervals as pitched roof replacement is recommended to ensure best performance and cost efficiency. Inspect regularly, keep gutters and downspouts free of debris to ensure water evacuating from rooftops as designed and repair as needed from general operating funds.

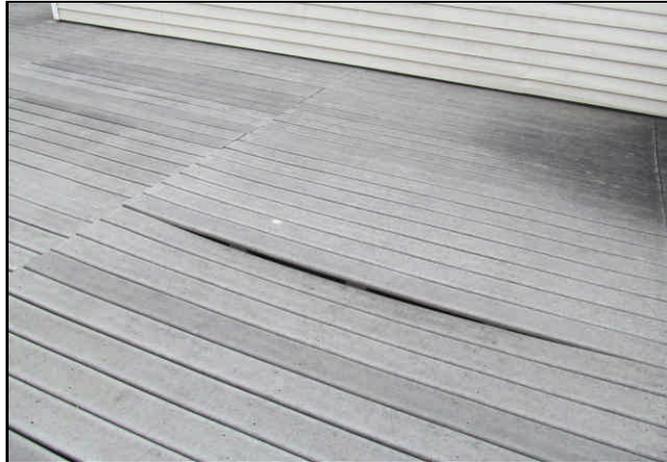
Location: Rooftop of buildings

Evaluation: Composite decking with general deterioration, areas with warping, height differential and concerns for safe pedestrian traffic. Replacement is recommended, timed to coincide with low slope roof replacement project for purposes of cost efficiency and long term planning. No specification or preliminary bids were available; similar (but improved) type of composite decking or wood is factored below at this time. Also, consideration should be given to durable concrete paver system (upon pedestals) as seen at many other rooftop decks. Further, some discussion is ongoing regarding a large scale redesign project whereby the roof decks would be completely enclosed as interior space but no consensus or firm plans at this time. That type of capital improvement endeavor would be funded outside of maintenance reserves in any event. Future reserve updates will factor any significant changes to building construction/amenities as a matter of course.

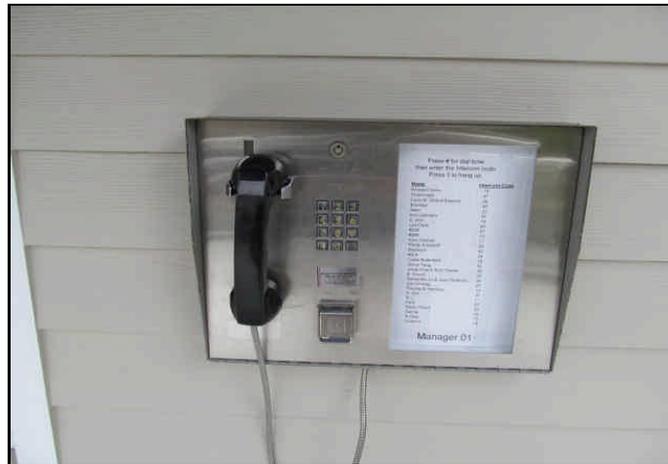
Location: Main entries of buildings

Evaluation: Panels are older with only general deterioration as expected. Functional when we inspected on 10.9.2012 with no reported problems. Proactive maintenance and minor repairs have helped to extend useful life. Plan for eventual replacement intervals due to constant usage, technological upgrades and potential parts obsolescence.

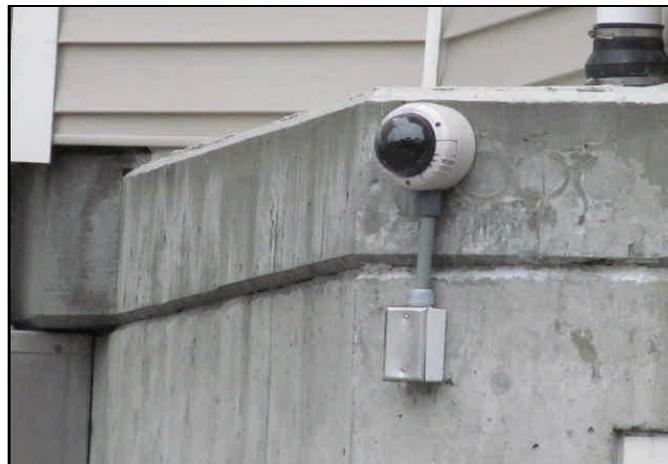
Location: Access/ entry and other common areas

Evaluation: It is our understanding that the four camera, DVR system was installed in 2011 at an expense of ~\$6,000. Failure rate is difficult to predict, but typically replacement is needed in the 10 year range; we have factored funds for integrated replacement equipment at this interval. Inspect and service periodically as needed.
