“Full” Reserve Study

Parc on Summit Seattle, WA

Report #: 17969-0
For Period Beginning: December 1, 2012
Expires: June 30, 2013

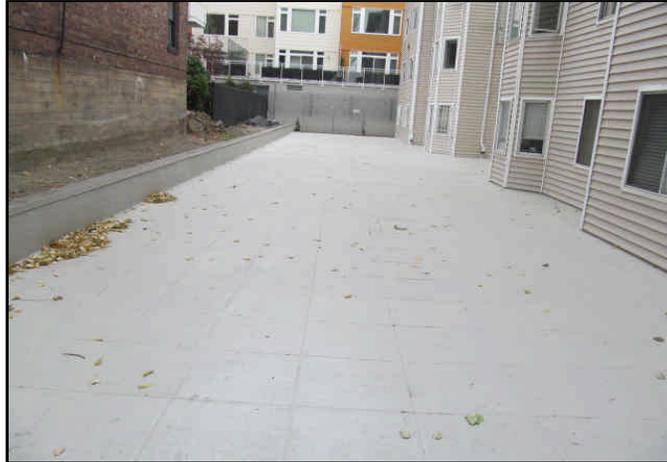
Remaining Life:

1 years

Best Case: \$8,000.00

Lower allowance to supplement the operating budget

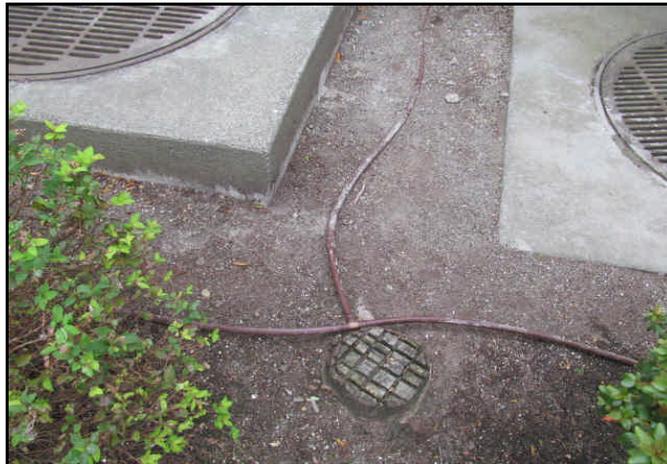
Comp #: 312 Irrigation System - Repair/Replace

Useful Life:
10 years

Remaining Life:
1 years

Best Case: \$4,000.00

Lower allowance to supplement the operating budget

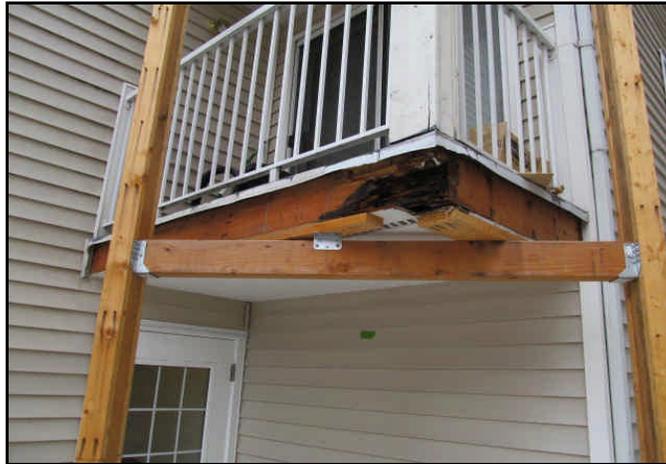
Remaining Life:
1 years

Best Case: \$64,000.00

\$4,000/each (x8) and \$2,000/each (x16) , lower allowance to repair/resurface

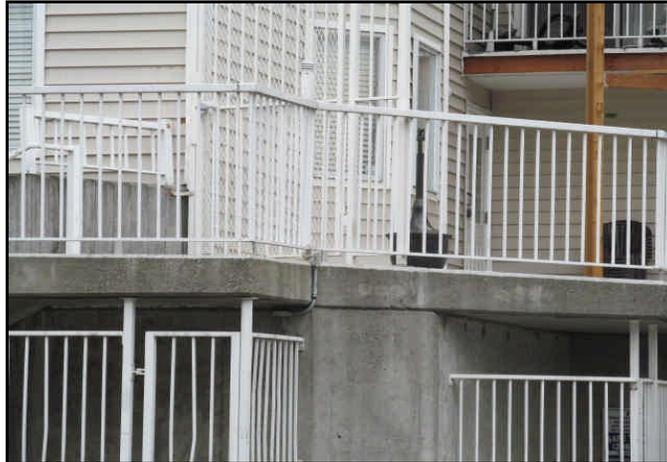
Useful Life:
30 years

Remaining Life:
1 years

Best Case: \$20,400.00

\$60/LF, lower average estimate to replace

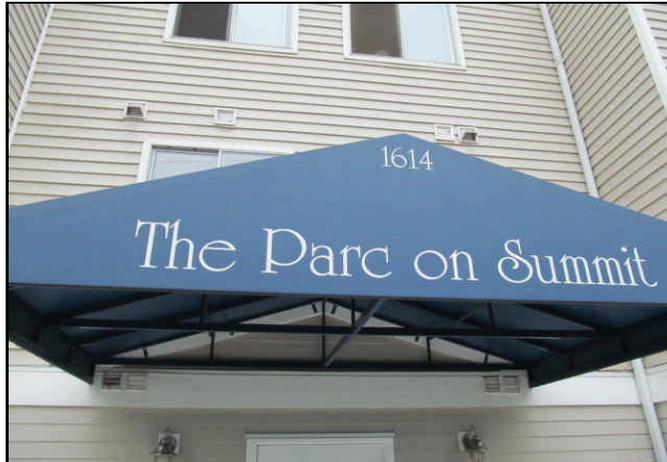
Useful Life:
12 years

Remaining Life:
7 years

Best Case: \$7,000.00

\$2,900 (x2) and \$300 (x4), lower allowance to replace material

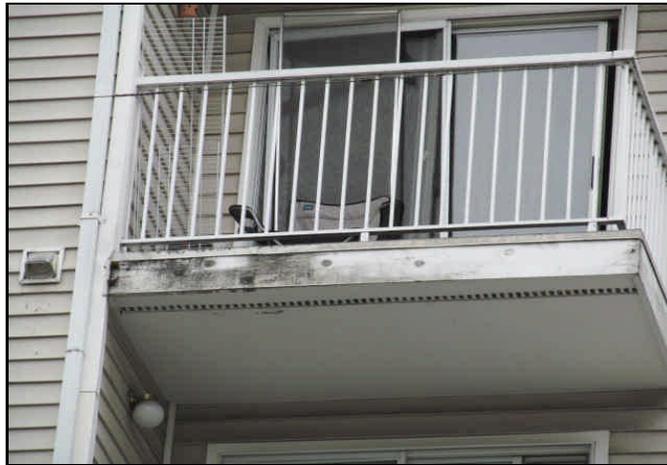
Useful Life:
10 years

Remaining Life:
1 years

Best Case: \$91,200.00

\$1,200/unit (x76), lower estimate to clean, caulk and paint

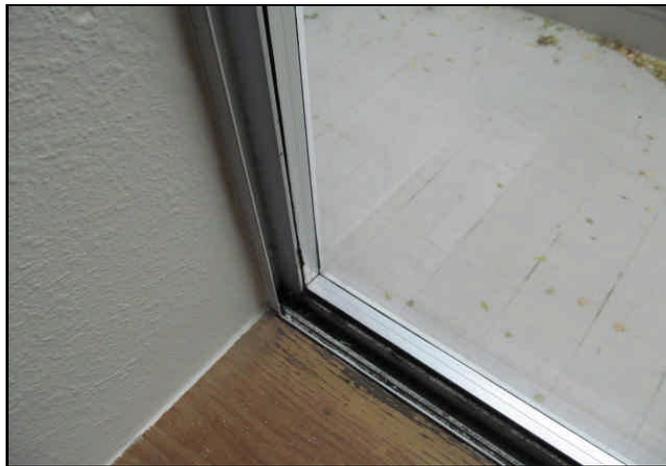
Useful Life:
30 years

Remaining Life:
1 years

Best Case: \$228,000.00
\$3,000/unit (x76), lower estimate to replace

Worst Case: \$304,000.00
\$4,000/unit (x76), higher estimate to replace

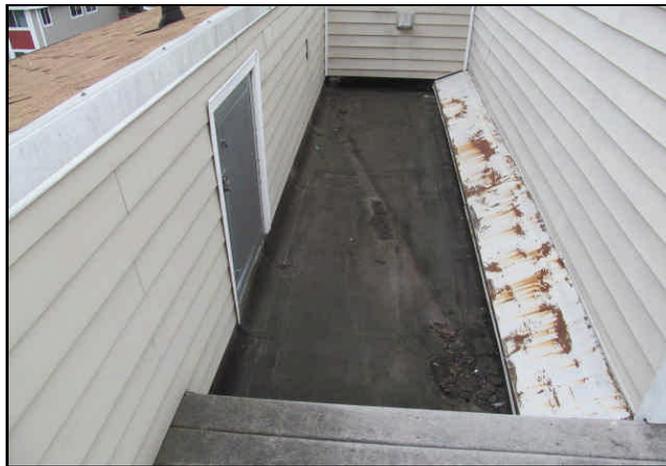
Useful Life:
20 years

Remaining Life:
1 years

Best Case: \$42,300.00

\$15.00/Sq Ft; lower estimate to roof, includes any metal work

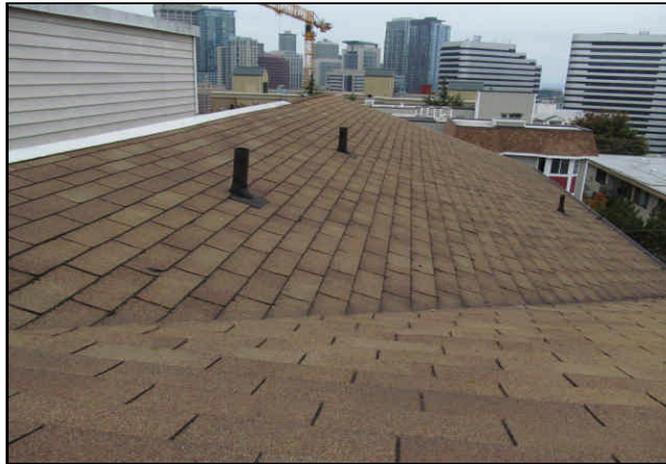
Useful Life:
30 years

Remaining Life:
1 years

Best Case: \$41,300.00

\$5.00/Sq Ft; lower estimate to roof, includes any metal work

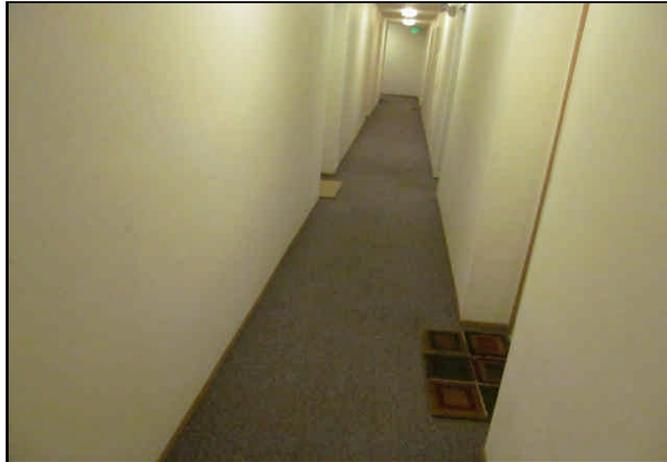
Useful Life:
12 years

Remaining Life:
2 years

Best Case: \$26,000.00

\$50/Sq Yd, lower allowance replacement flooring,
installed

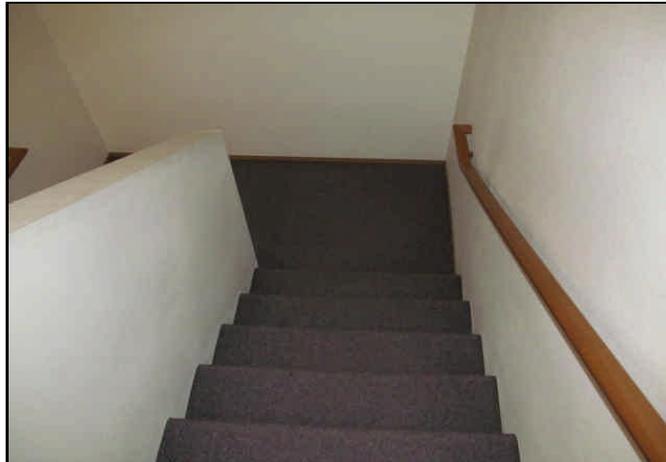
Useful Life:
20 years

Remaining Life:
2 years

Best Case: \$20,800.00

\$40/Sq Yd, lower estimate replacement flooring installed

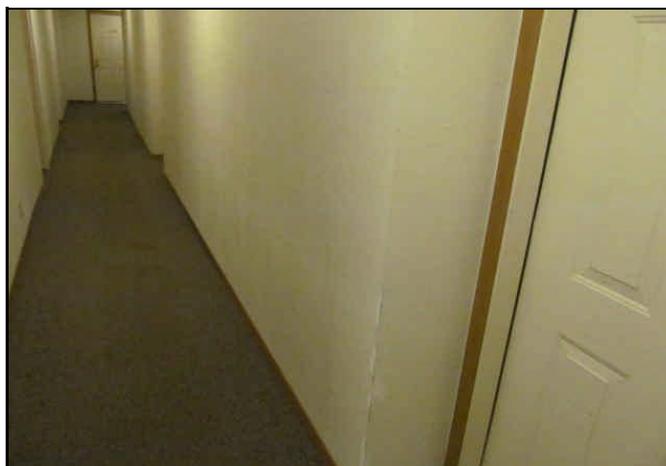
Useful Life:
12 years

Remaining Life:
2 years

Best Case: \$21,000.00

Lower allowance to refinish, similar scheme

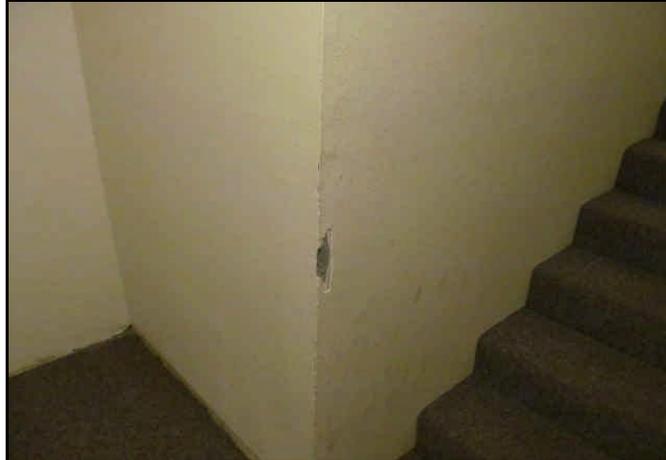
Useful Life:
20 years

Remaining Life:
2 years

Best Case: \$11,600.00

Lower estimate to paint, similar scheme

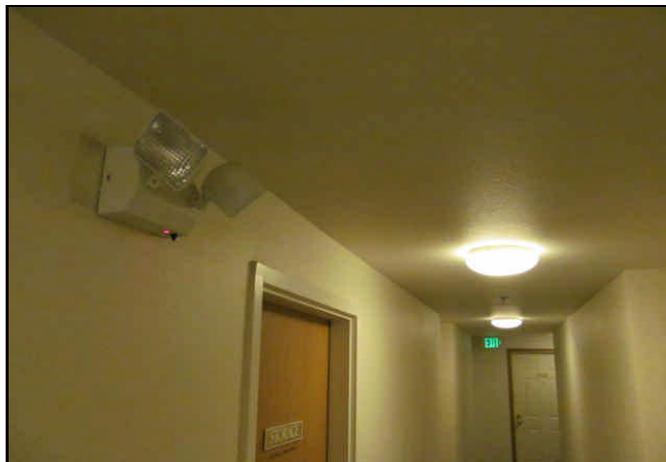
Useful Life:
24 years

Remaining Life:
2 years

Best Case: \$31,200.00

\$100/each (x312), lower allowance to replace

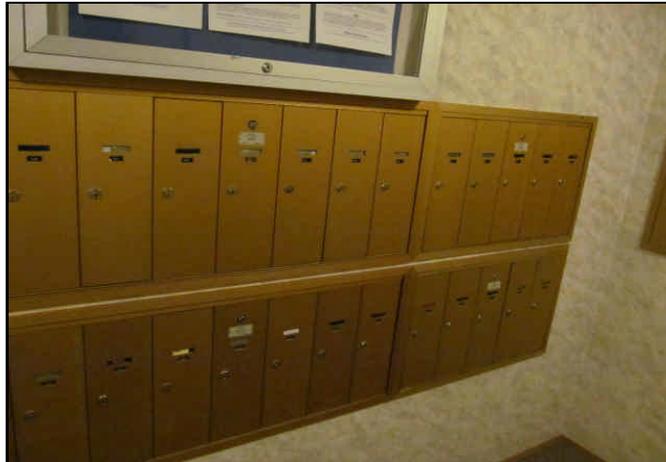
Useful Life:
30 years

Remaining Life:
8 years

Best Case: \$5,460.00

Lower estimate, includes installation

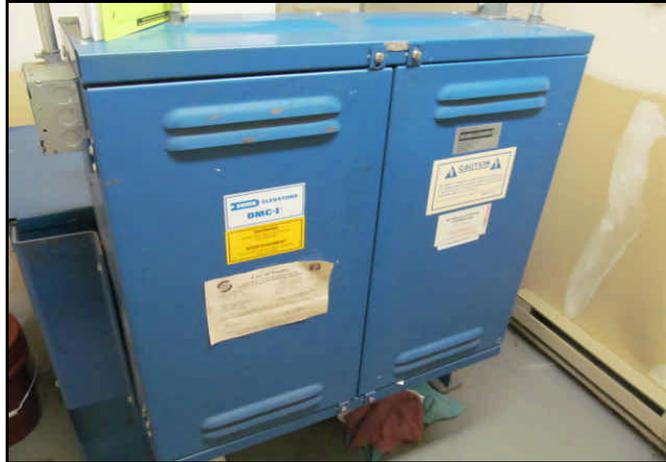
Useful Life:
30 years

Remaining Life:
8 years

Best Case: \$110,000.00

\$55,000 each (x2), lower estimate to modernize elevator and cabs

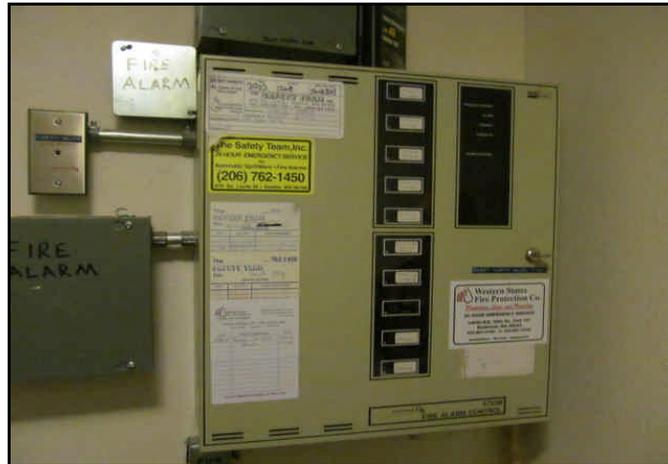
Useful Life:
25 years

Remaining Life:
3 years

Best Case: \$7,500.00

Worst Case: \$10,000.00

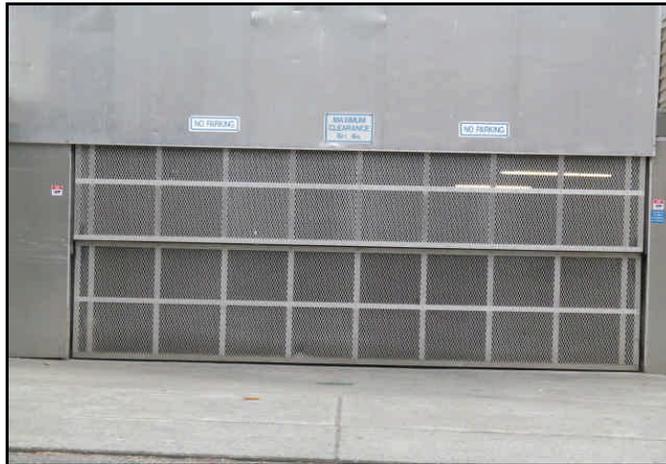
Useful Life:
35 years

Remaining Life:
13 years

Best Case: \$12,000.00

Lower estimate to replace door with similar

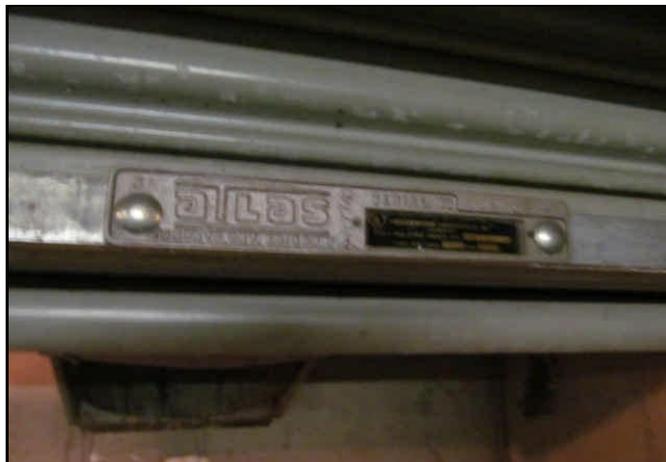
Comp #: 929 Trash Room Doors - Replace

Evaluation: Not tested. Working assumption is minimal usage with individual repairs or any eventual replacements when needed from general funds.

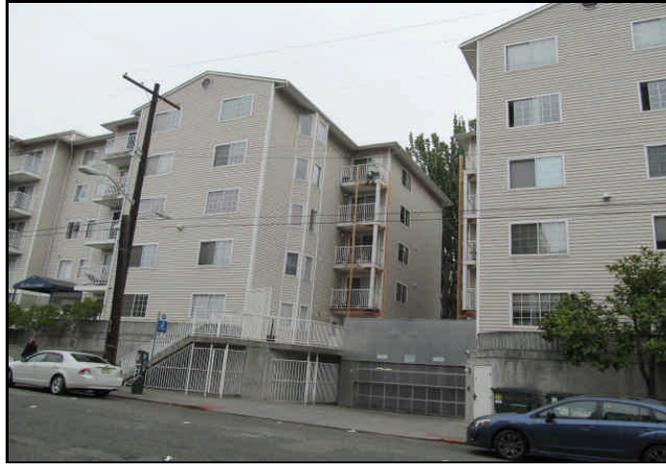
Evaluation: Forensic building inspection is beyond the scope of a Reserve Study. Many Associations are required to have the Condominium inspected annually by a qualified engineer or architect in order to ascertain the physical condition of the improvements in the Condominium and to determine whether maintenance, repairs or replacements of any improvements are indicated. The inspection typically covers, at a minimum, the building envelopes, including the roofs, siding, caulking, flashings, windows, decks and doors. Although your Associations governing documents do not appear to require such, we recommend the Board provide for regular comprehensive building inspections, funded from the maintenance/operating budget, to ensure the weatherproofing and structural integrity of the buildings is maintained.

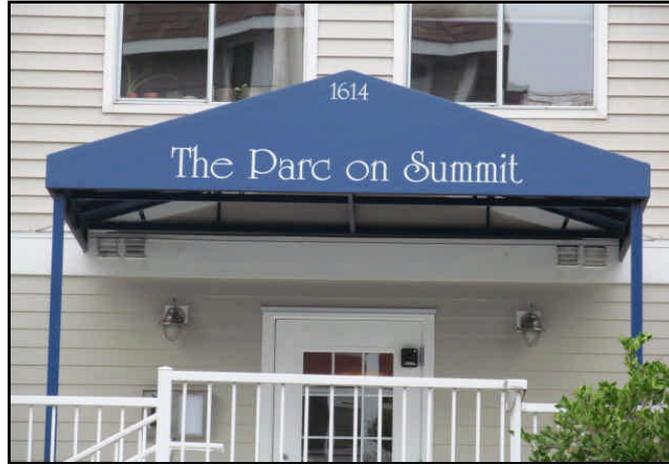
Evaluation: Per Washington law, chapter 64.34 RCW reserve study updates with site inspections are required every three years to assess changes in condition (i.e., physical, economic, governmental, etc...) and the resulting effect on the community's long-term reserve plan. Most appropriately factored through operating budget, not as reserve component.
